The Road Inventory of Alamosa National Wildlife Refuge Alamosa, CO

Prepared By:
Federal Highway Administration
Central Federal Lands Highway Division
September 2008

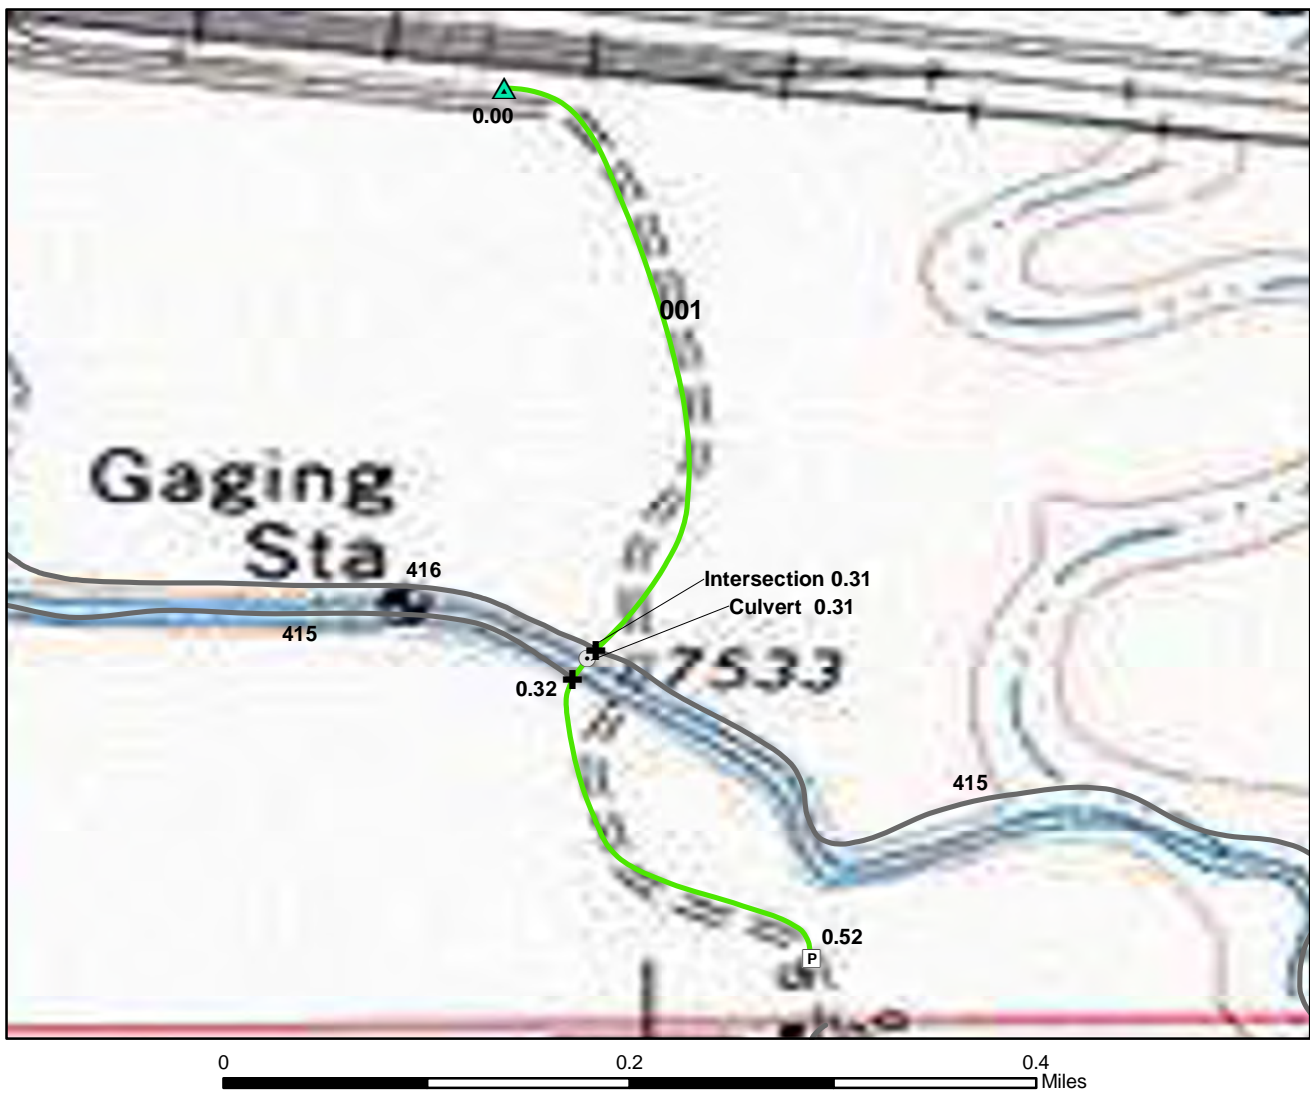
RTE DESCRIPTION: From Visitor Center Loop (Route 101) to Headquarters
Lateral Road (Route 406)

Section Number	001	002	003	004	
Section Length (miles)	1.01	0.99	1.00	0.18	
Inspection Date	9/27/2008	9/27/2008	9/27/2008	9/27/2008	
Section Information					
Surface Type	Gravel	Gravel	Gravel	Gravel	
Number of Lanes	1	1	1	1	
Roadway Width (feet)	14	14	14	14	
Roadway Condition Information					
Condition	Excellent	Excellent	Excellent	Excellent	
Remaining Service Life (years)	8	8	8	8	
Cost Estimate	\$0	\$0	\$0	\$0	
CRV	\$731000	\$716500	\$723700	\$130300

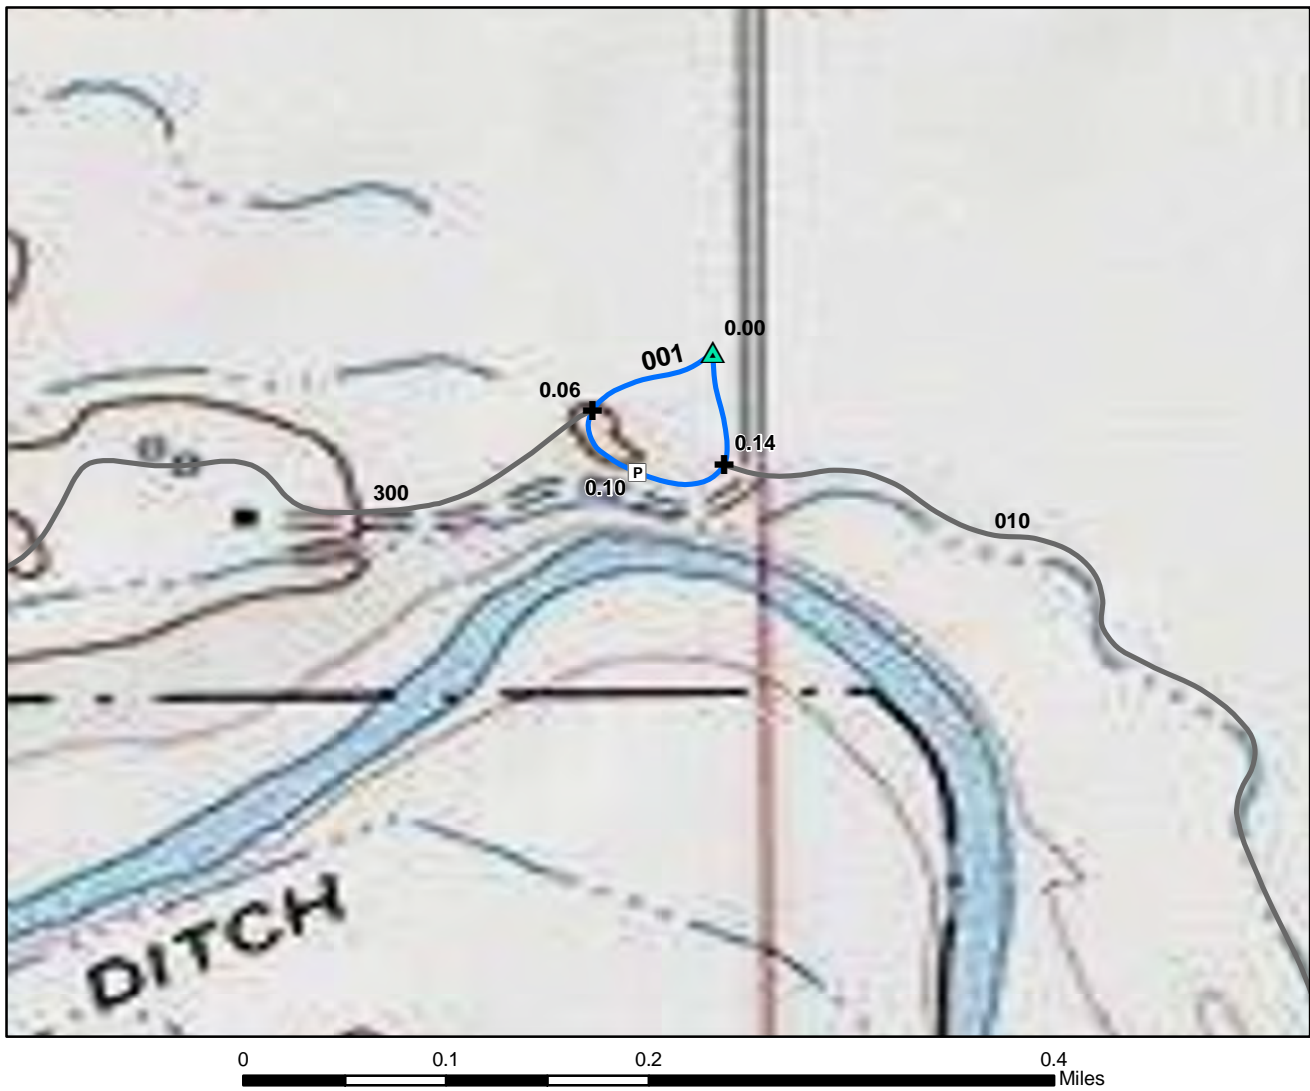
ROUTE: 100 Bluff Overlook Drive TOTAL LENGTH: 1.69 Miles

RTE DESCRIPTION: From Baca Lane North to Baca Lane South

Section Number	001	002			
Section Length (miles)	1.00	0.69			
Inspection Date	9/24/2008	9/24/2008			
Section Information					
Surface Type	Native	Native			
Number of Lanes	1	1			
Roadway Width (feet)	14	14			
Roadway Condition Information					
Condition	Fair	Fair			
Remaining Service Life (years)	4	4			
Cost Estimate	\$2300	\$1600			
CRV	\$374400	\$258300

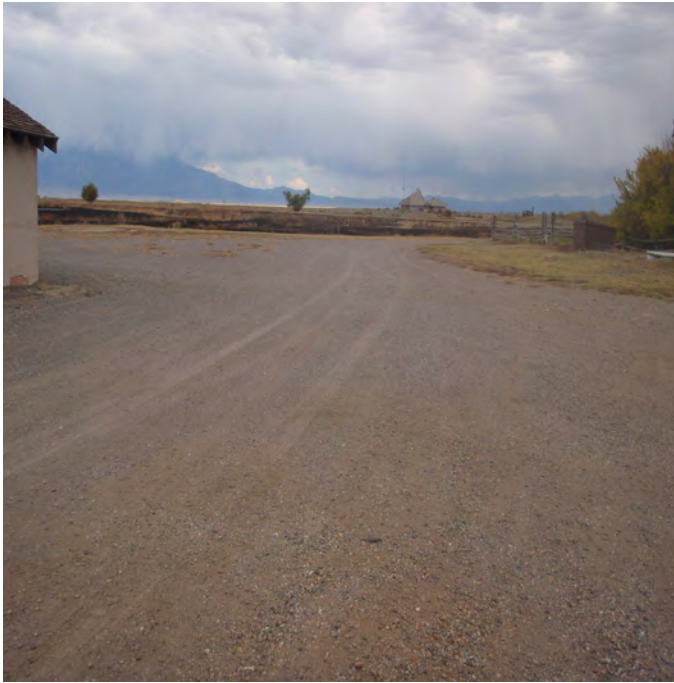
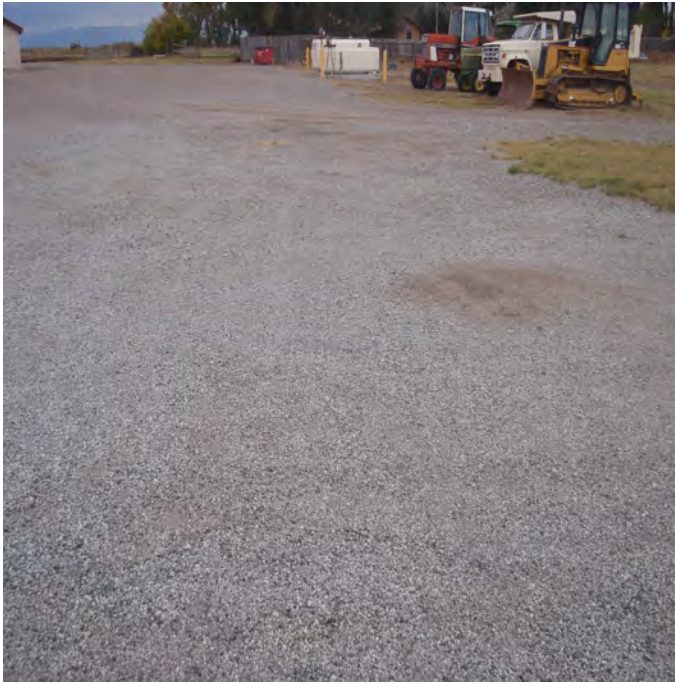
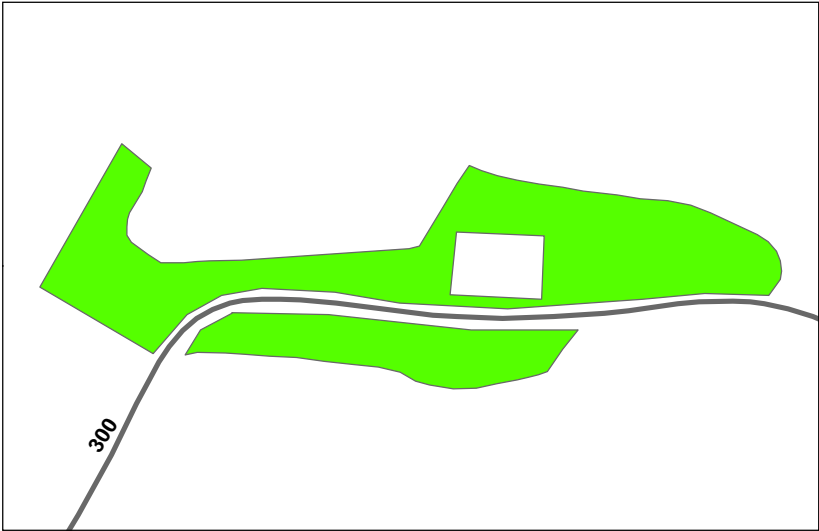
Route 800: Shop Parking Lot

Asset Number	Date Visited	Surface Type	Area (sq ft)	Condition	Cost to Improve
10049286	9/27/2008	Gravel	28223	Good	\$4500

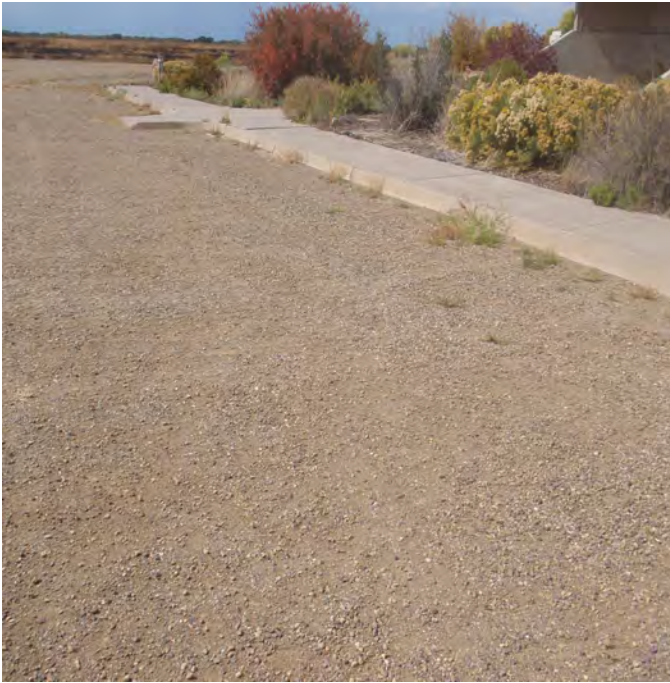
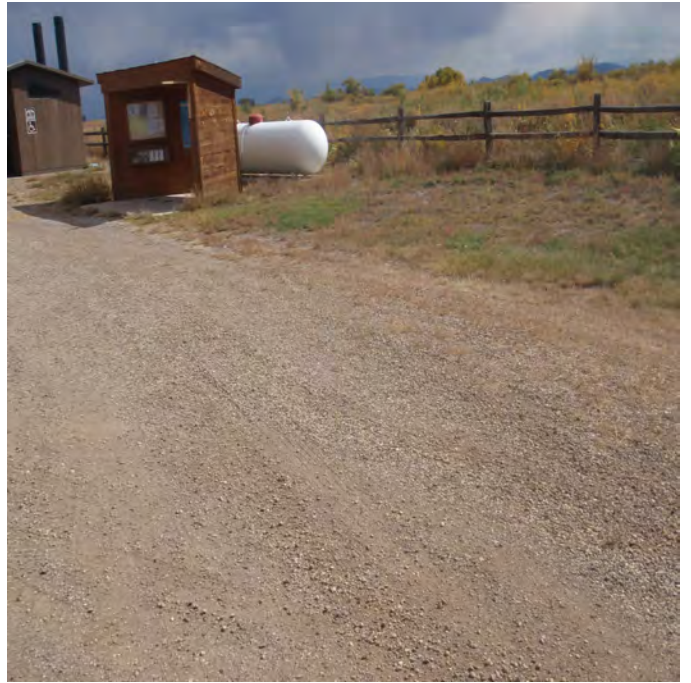
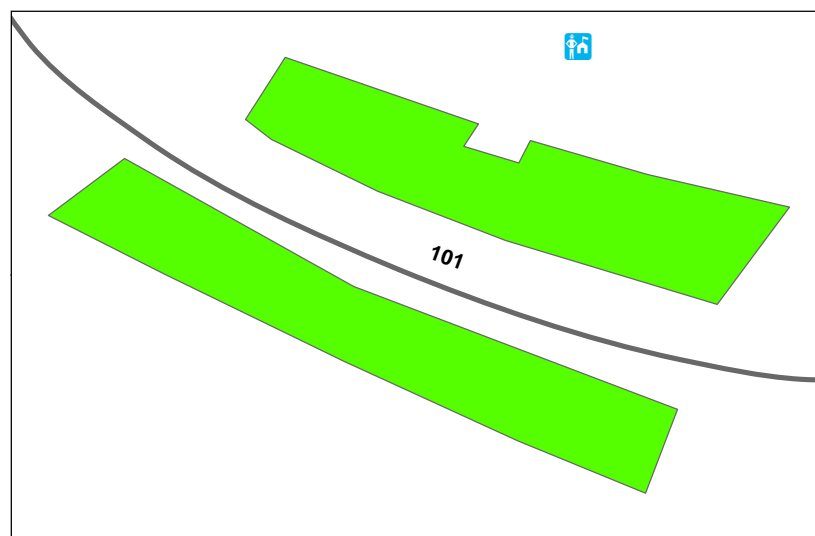
Route 900: Visitor Center Parking

Asset Number	Date Visited	Surface Type	Area (sq ft)	Condition	Cost to Improve
10033324	9/27/2008	Gravel	6605	Good	\$1000

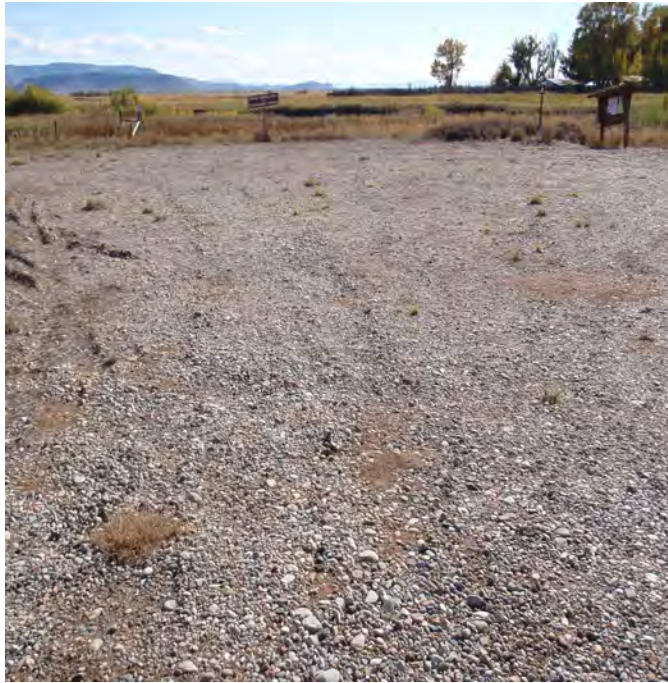
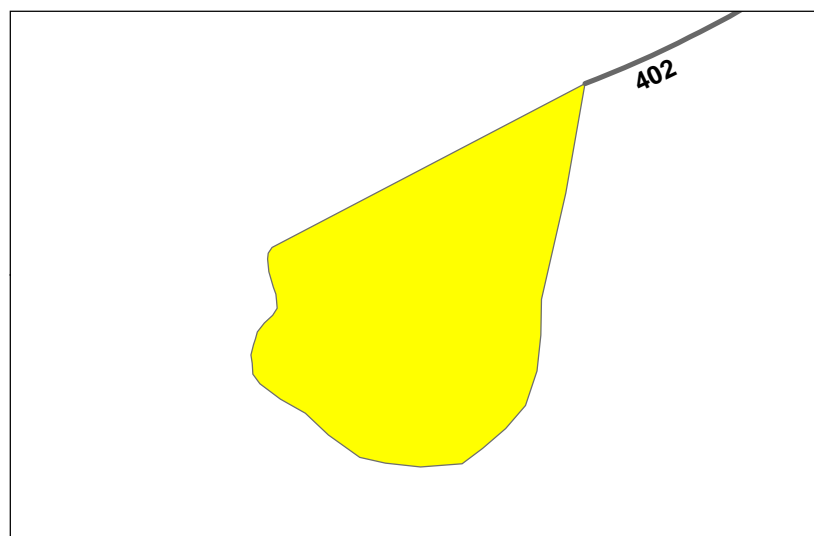
Route 902: Hunter Parking Lot 4

Asset Number	Date Visited	Surface Type	Area (sq ft)	Condition	Cost to Improve
10033266	9/24/2008	Gravel	5123	Fair	\$1400

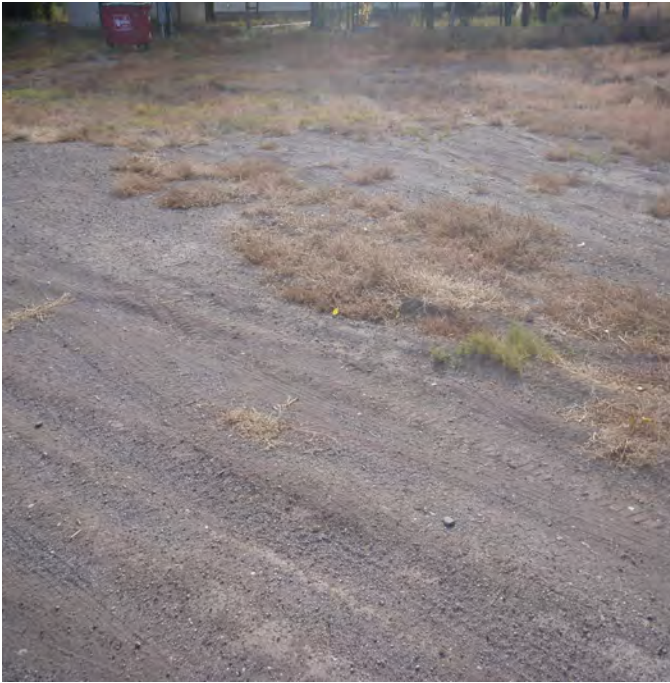
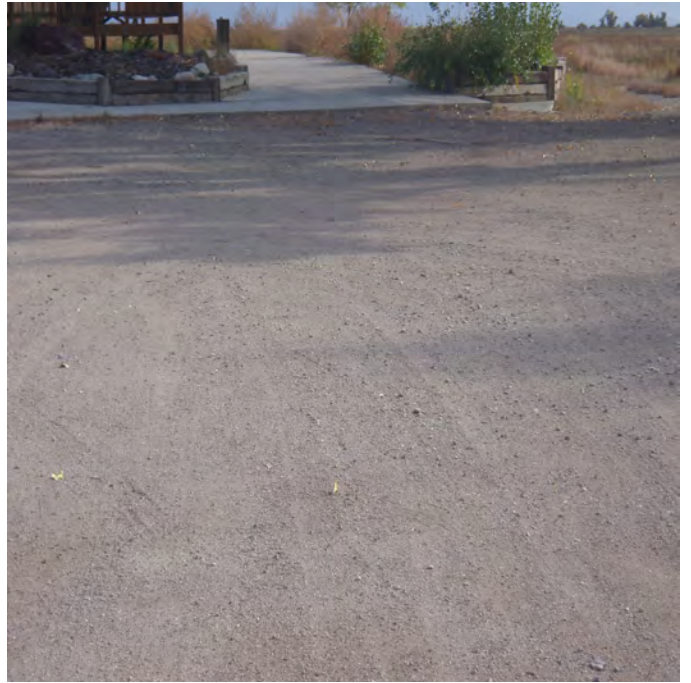
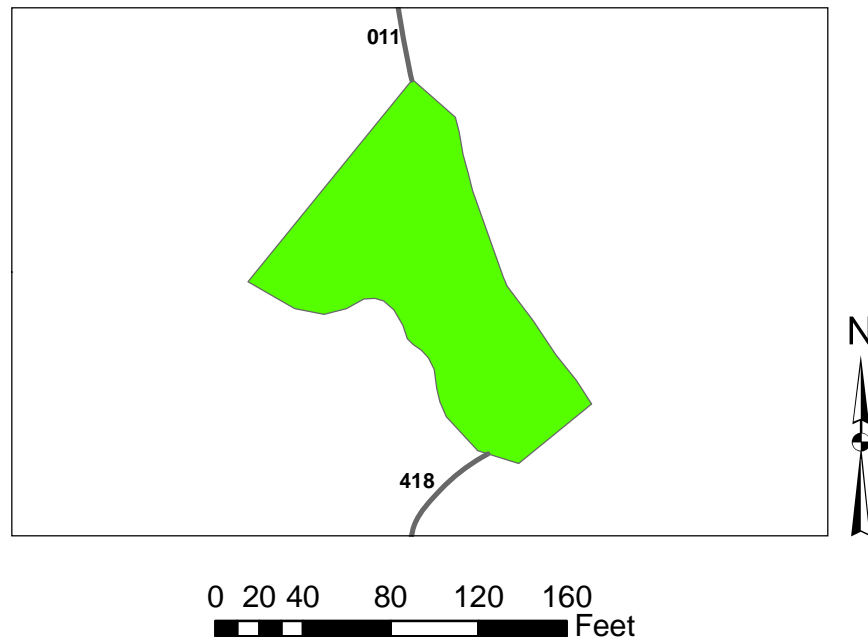
Route 906: Entrance Road Parking

Asset Number	Date Visited	Surface Type	Area (sq ft)	Condition	Cost to Improve
10033343	9/27/2008	Gravel	8753	Good	\$1400
